**RE: Bronco Utah Operations LLC
Emery Mine
DOG M Permit No. C/015/0015
Emery 2 Second Left Panel Full Extraction Revision Clean Copy task 5847**

The purpose of this report is to present baseline surface conditions prior to full extraction operations from the Emery 2 portal of the Bronco Utah Operations, LLC. (Bronco) Emery Mine, Emery County, Utah. The areas covered in this report include the following:

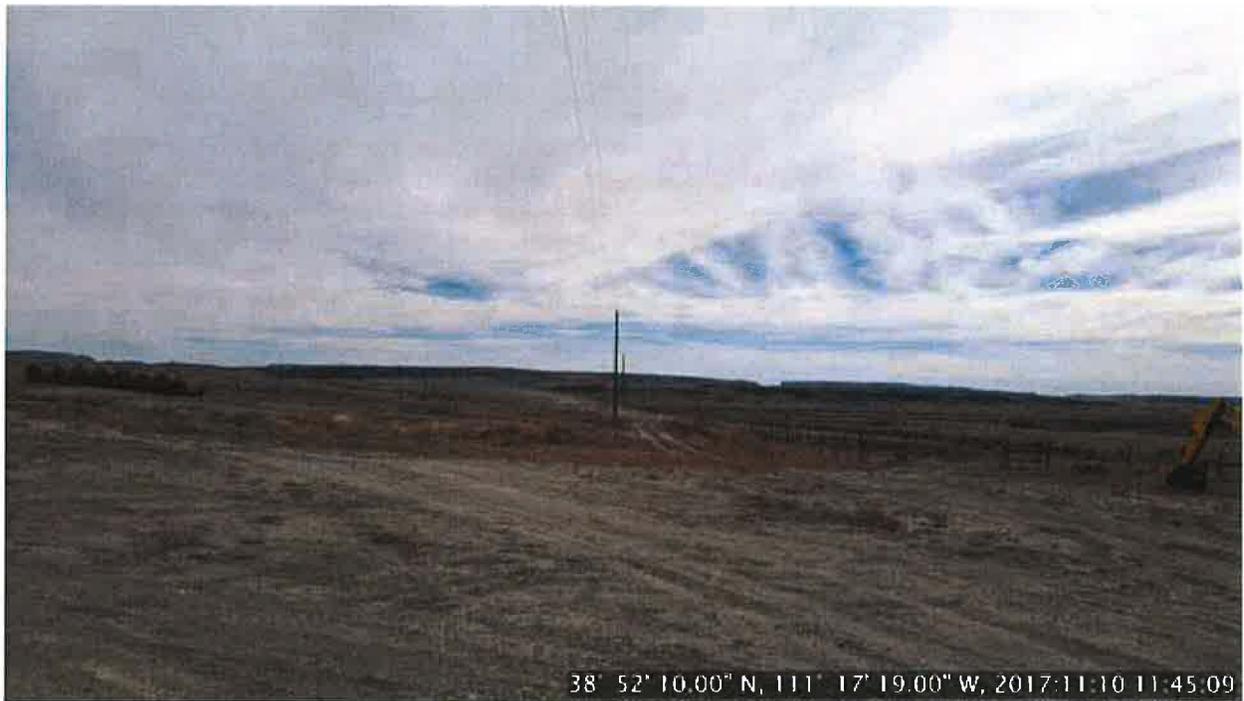
Feature 36. Utility Power Line. The description of this feature has been updated from the Valley Engineering (1980) report. A portion of this feature is located within a buffer zone, depicted on Figure 1 and Plate V-5, where subsidence is not anticipated. The electrical power line is a single line that supplies electricity to the ranch house and buildings (Feature 35). The poles are typical power line poles, approximately 35 feet tall and in good condition. The eastern most pole in this line, which also forms a part of the north/south power line (Feature 5) that this line ties into, leans to the south and west.

Feature 36. Utility Power Line. Looking southeast.

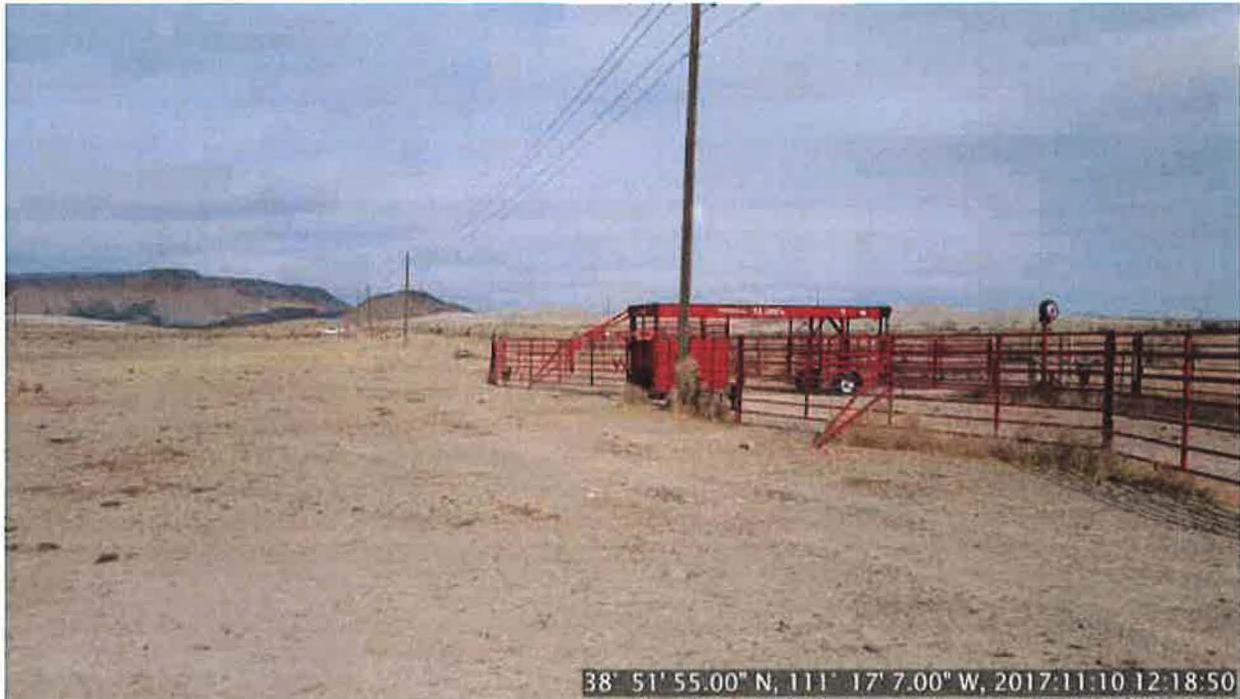
Feature 37. Feed Pens and Fence Line. The description of this feature has been updated from the Valley Engineering (1980) report. The feed pens are constructed of painted steel, are semi-portable, and are in good condition. The fence in the background of the photograph is a barbed wire fence with natural cut log posts. A portion of the fence is located within a buffer zone, depicted on Figure 1 and Plate V-5, where subsidence is not anticipated. The fence is fairly new and in excellent condition.

Feature 37. Feed Pens and Fence Line. Looking north.

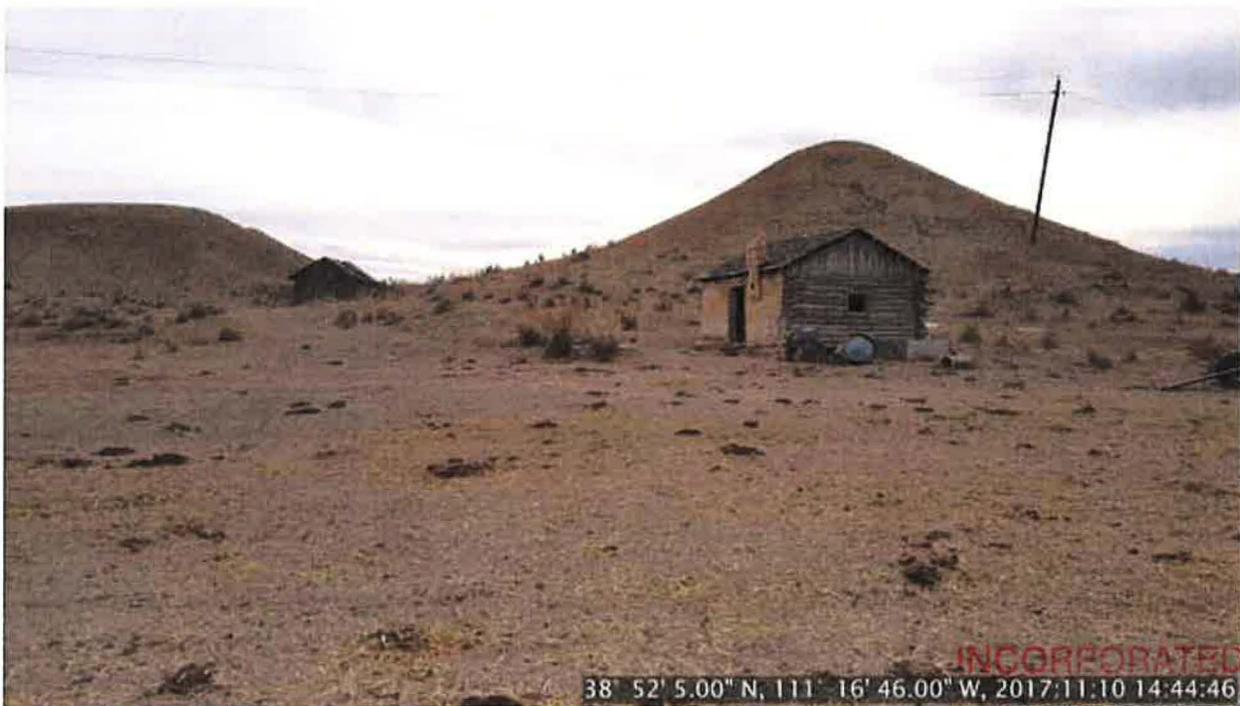
Feature 39. Log Cabins. The title and description of this feature have been updated from the Valley Engineering (1980) report. The corrals mentioned in the 1980 report have been removed. There are two log cabins at this location. The cabins are made of rough cut wood logs and are founded on wood or stacked rocks. Both cabins are in dilapidated condition.

Feature 39. Log Cabins. Overview looking south. Cabin 1 in foreground. JAN 24 2019

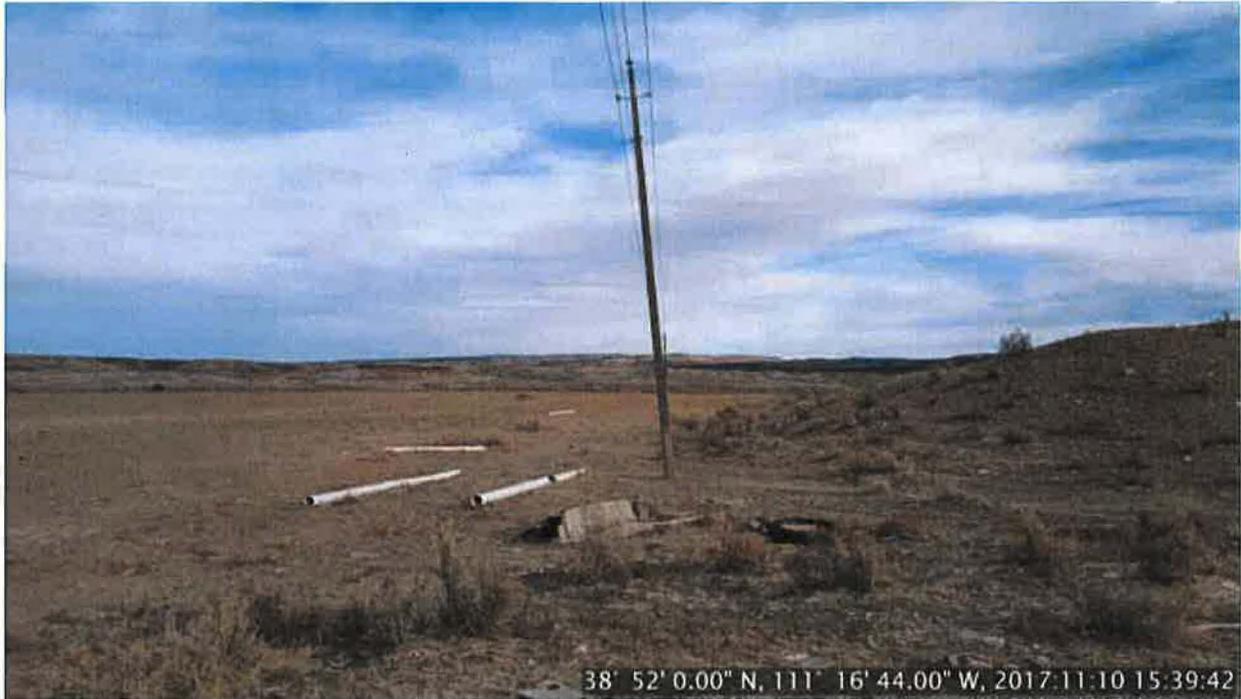
Feature 39. Log Cabins. Looking east along power line. Top of pole in foreground leans to left.

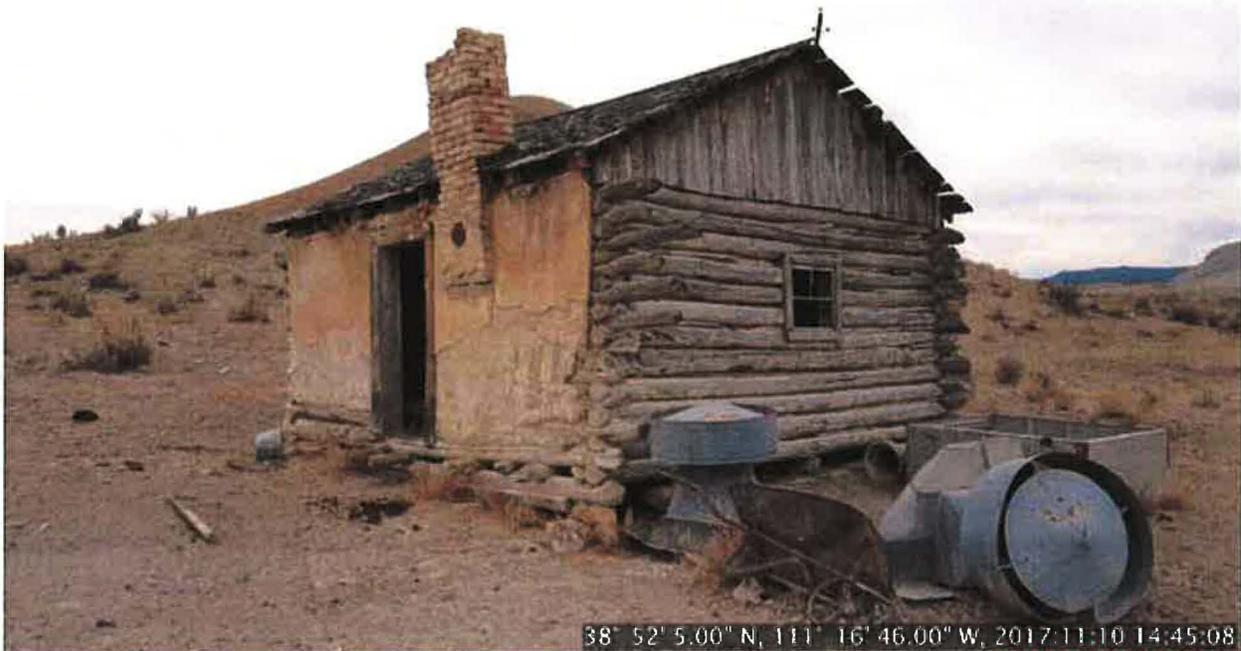
Feature 39. Log Cabins. Cabin 1 looking south.

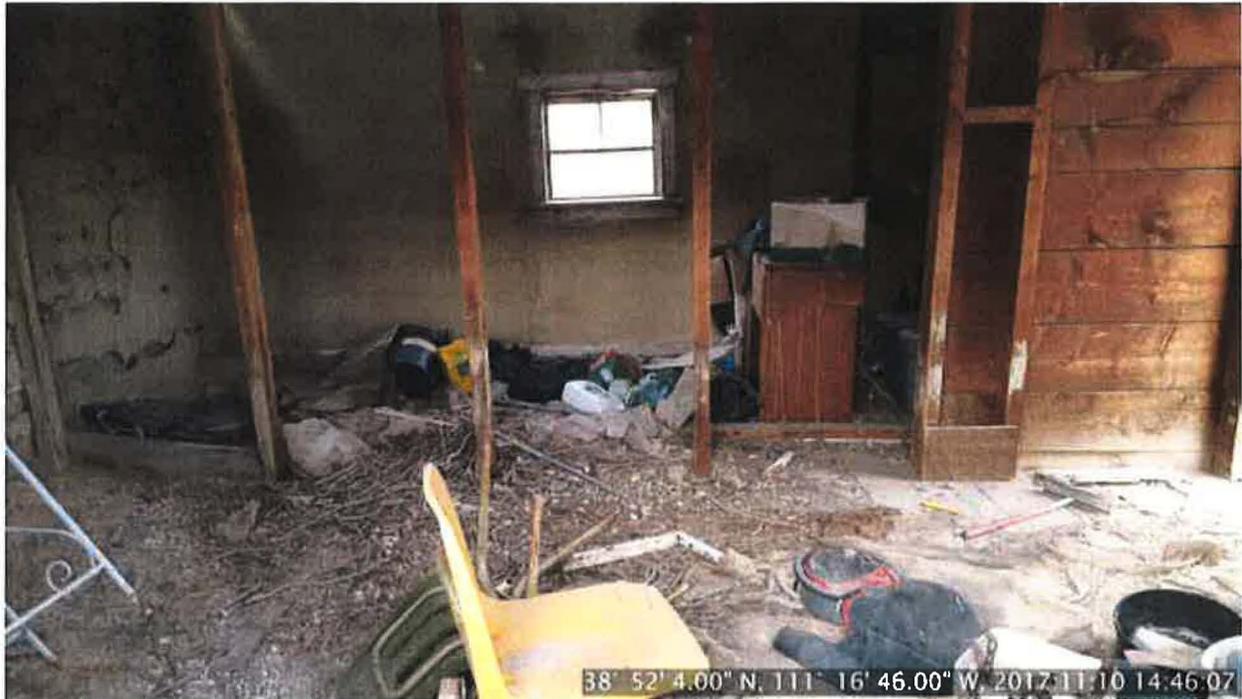
Feature 39. Log Cabins. Inside view of cabin 1.

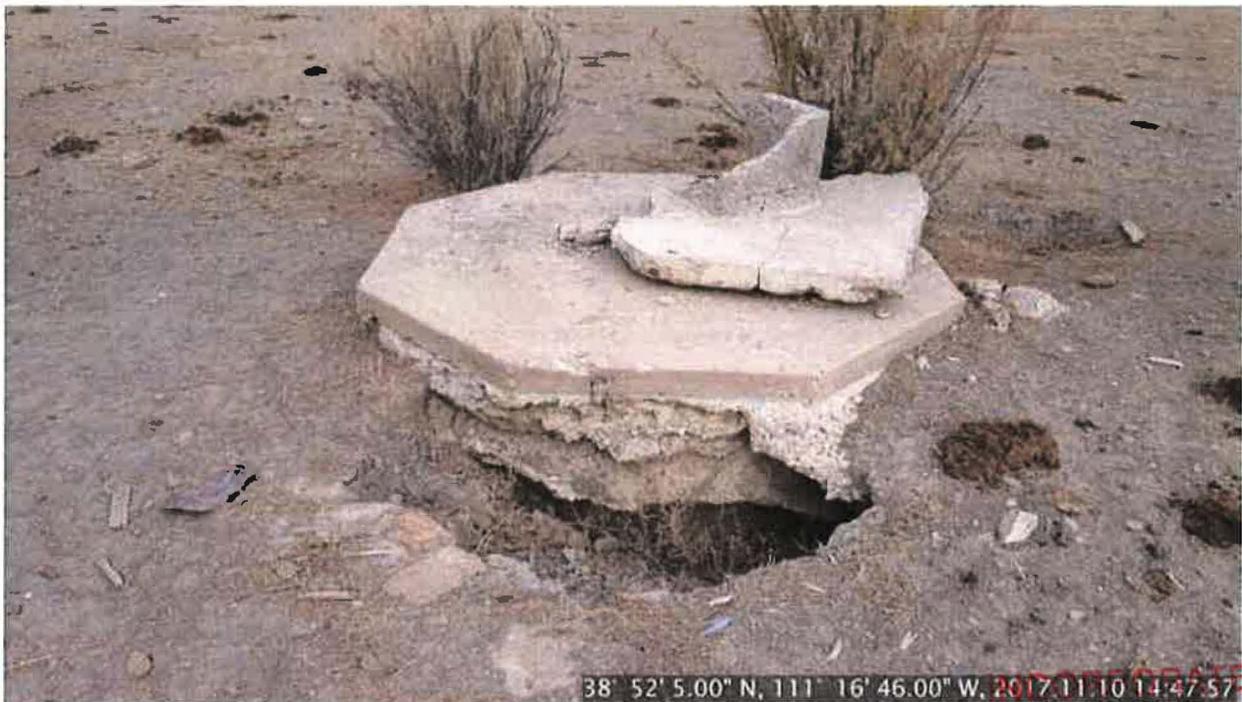
Feature 39. Log Cabins. Concrete structure outside cabin 1. Likely a septic tank.

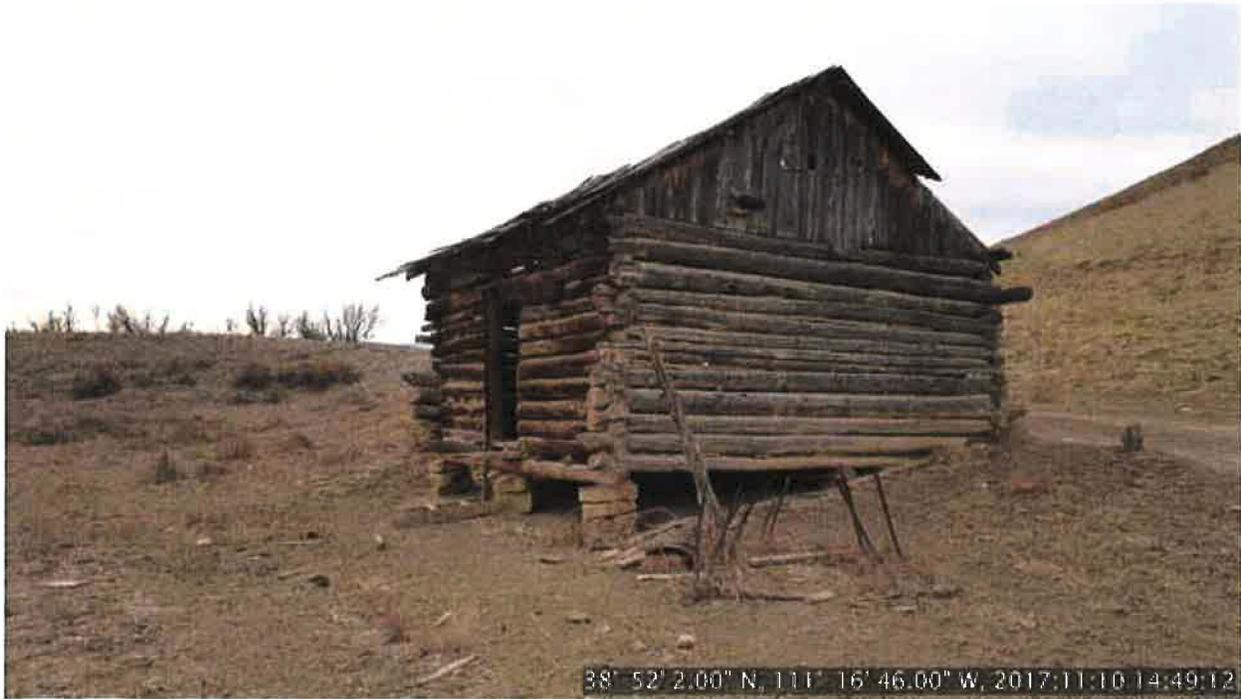
Feature 39. Log Cabins. Cabin 2 founded on rock pieces.

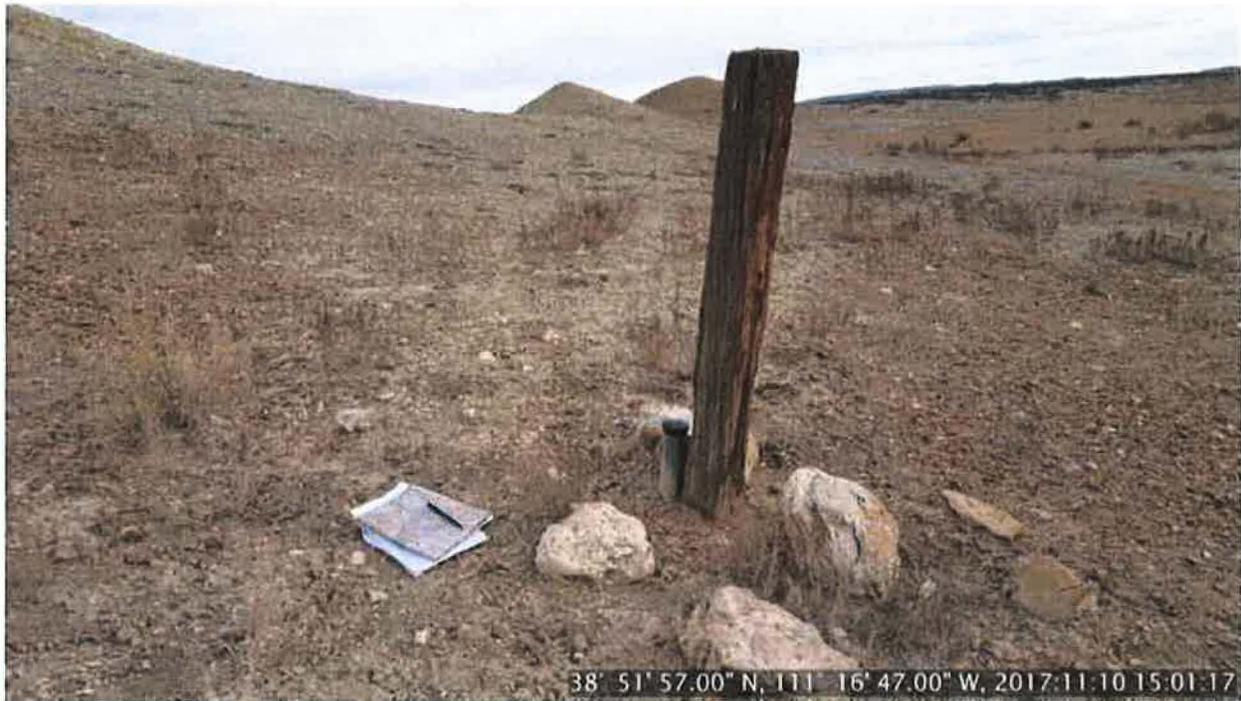
Feature 40. Section Corner Marker. Looking east.

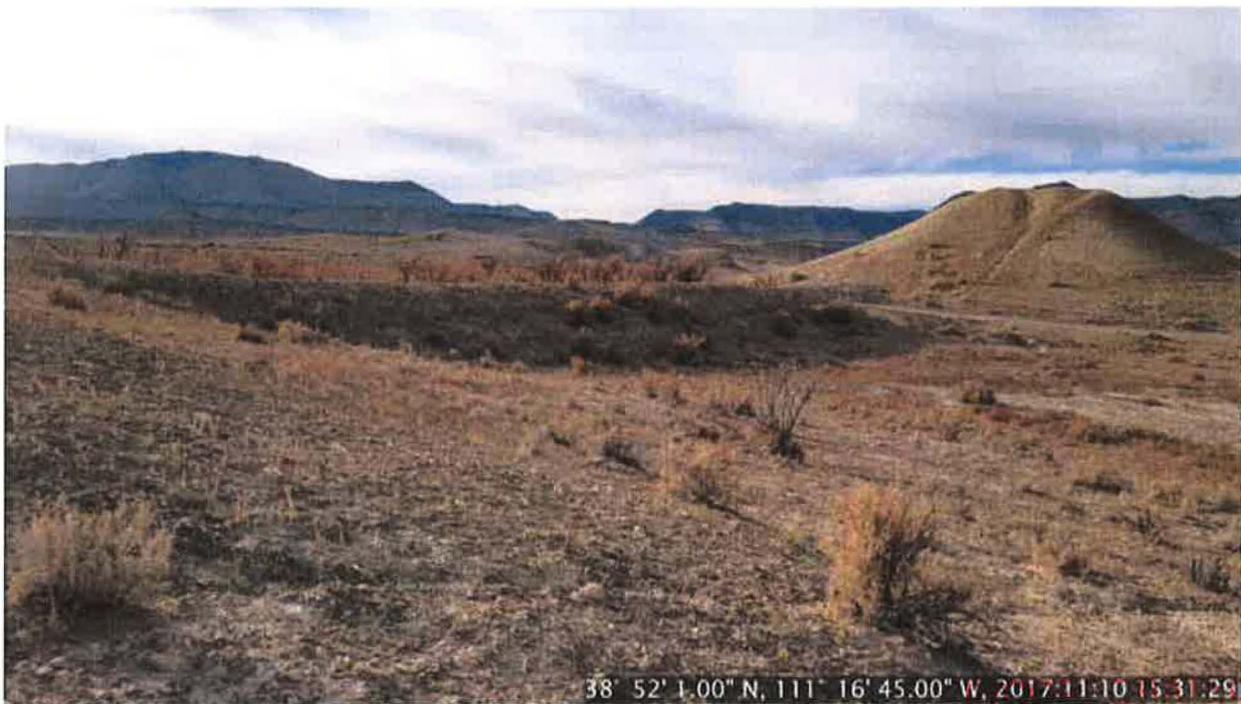
Feature 41. Pond. The description of this feature has been updated from the Valley Engineering (1980) report. The pond was constructed by installing an approximately 8 foot tall berm between two small hills. The berm is approximately 250 feet long and approximately 6 feet wide at its crest. The berm is located approximately 100 yards north of the section corner marker (Feature 40). A 25 foot long by 3 foot deep path has been worn through the western end of the berm. Water flows out of the pond via a 16" PVC riser. The pond was dry at the time of the survey.

Feature 41. Pond. Looking southwest at face of earthen dam. This dam situated between two small hills forms the north side of the pond.

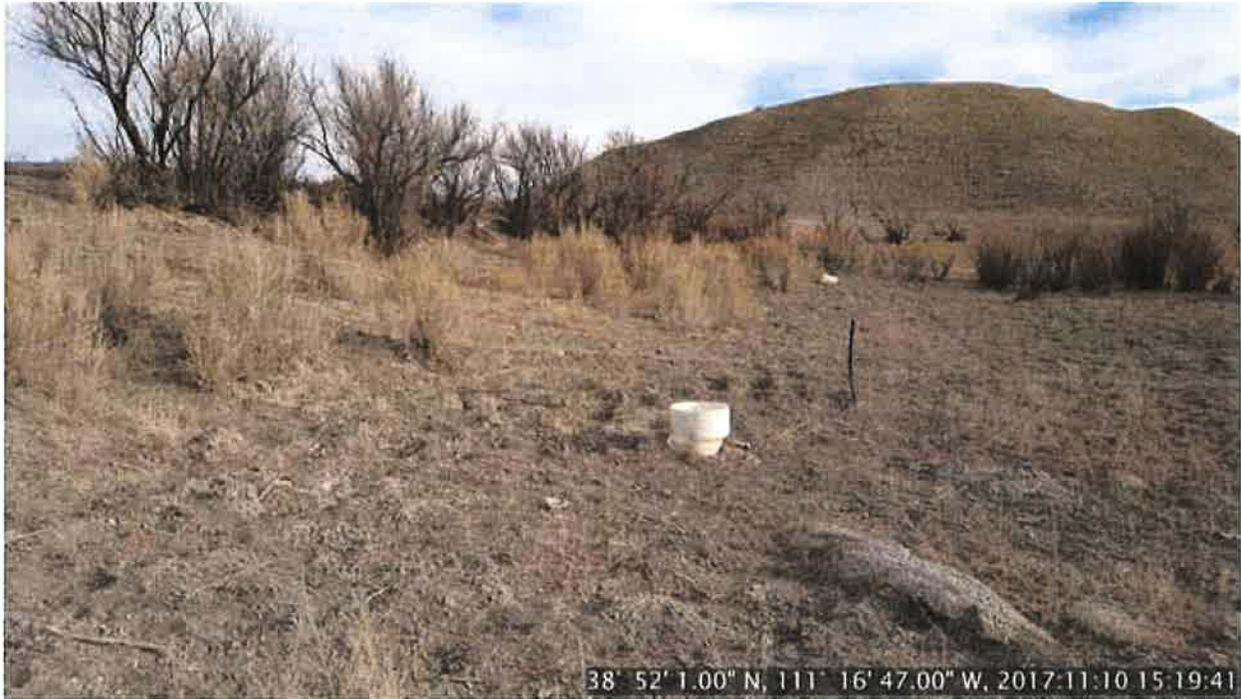
Feature 41. Pond. Water exits this pond through a 16" PVC riser near the dam.

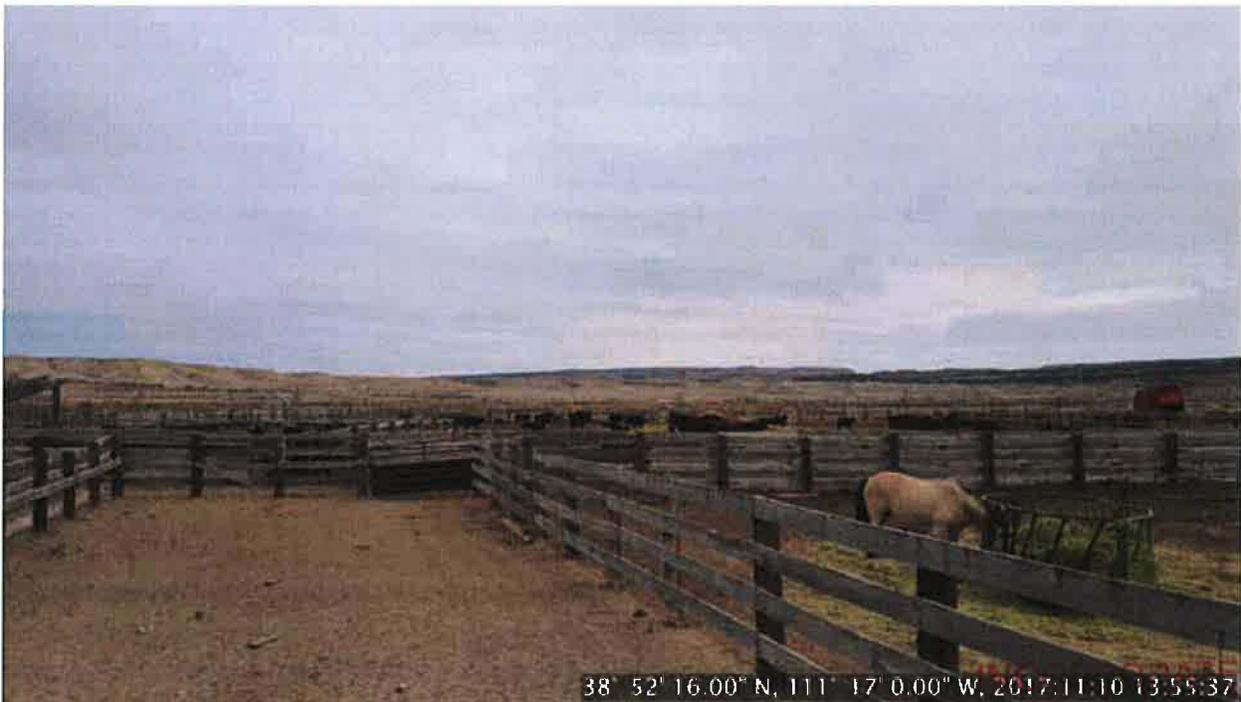
Feature 43. Corrals and Grain Silo. The description of this feature has been updated from the Valley Engineering (1980) report. This feature is located within a buffer zone, depicted on Figure 1 and Plate V-5, where subsidence is not anticipated. The corrals and feeding areas are constructed of rough cut lumber, timber posts, and railroad ties and are in good condition. The gates to the corrals are made of steel pipes and are in good condition. The galvanized steel grain silo, located approximately 180 yards west of the southwestern corner of the corrals, rests on a concrete pad and is in good condition.

Feature 43. Corrals and Grain Silo. Looking north from center of corral.

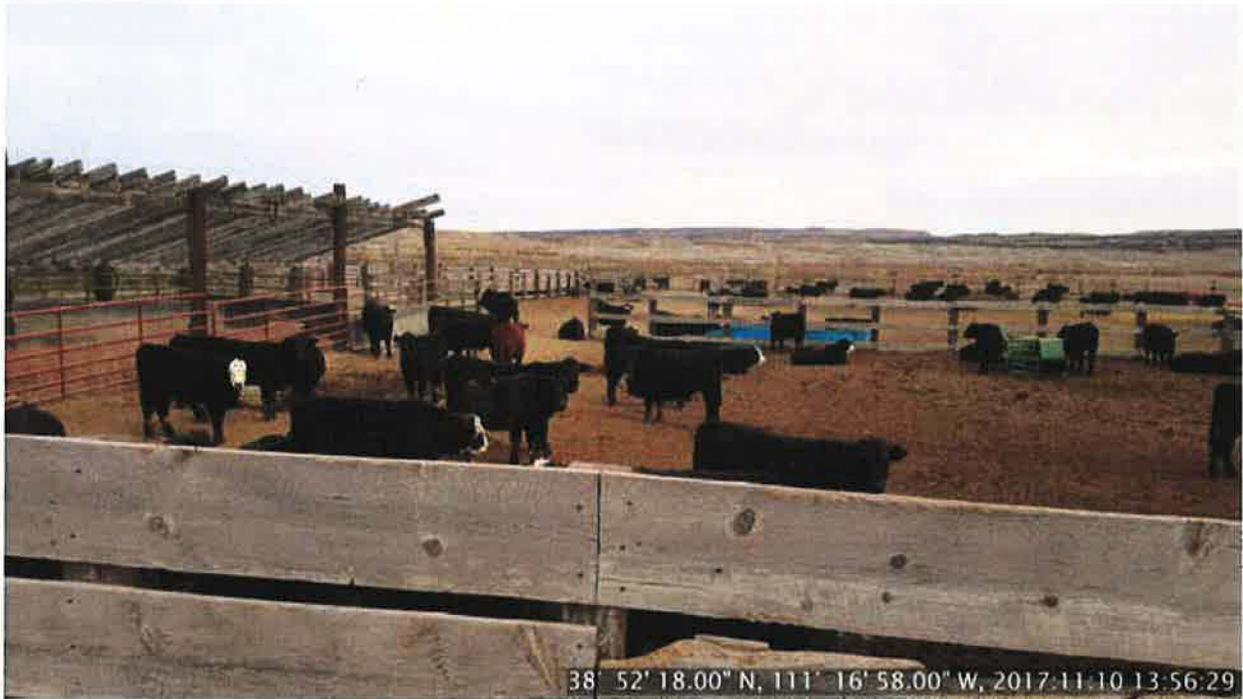
Feature 43. Corrals and Grain Silo. Looking east from center of corral.

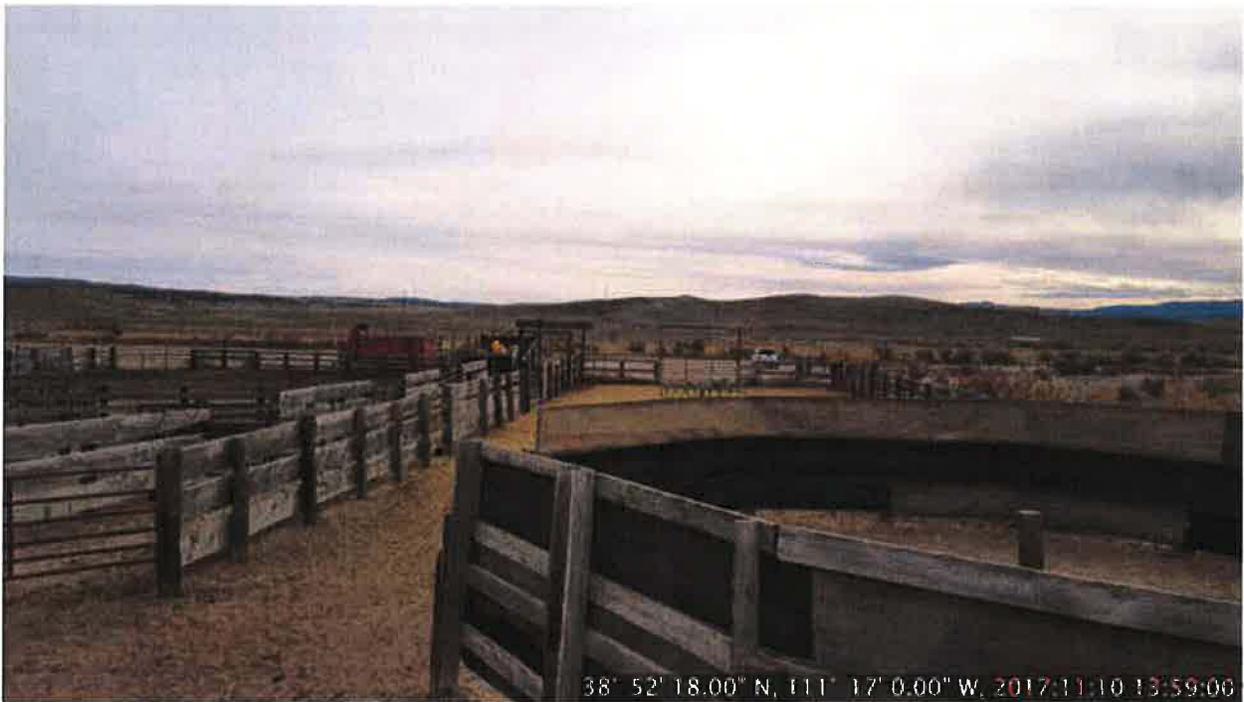
Feature 43. Corrals and Grain Silo. Looking west from center of corral.

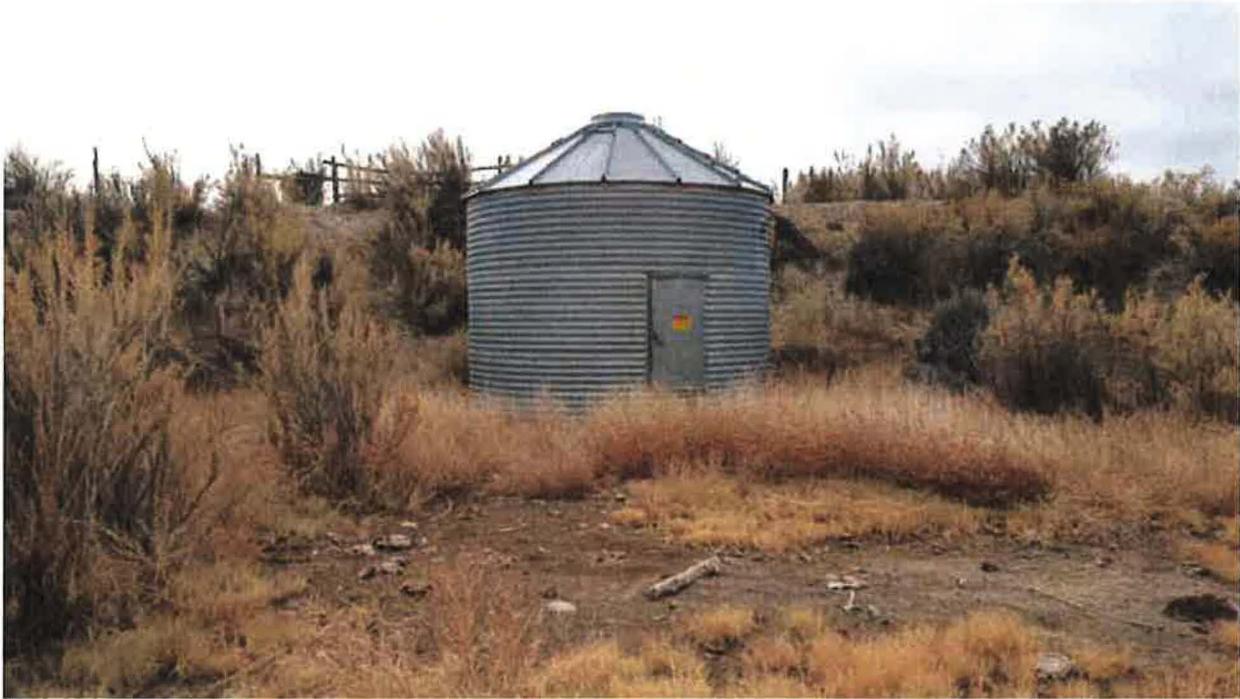
Feature 43. Corrals and Grain Silo. Looking south at grain silo.

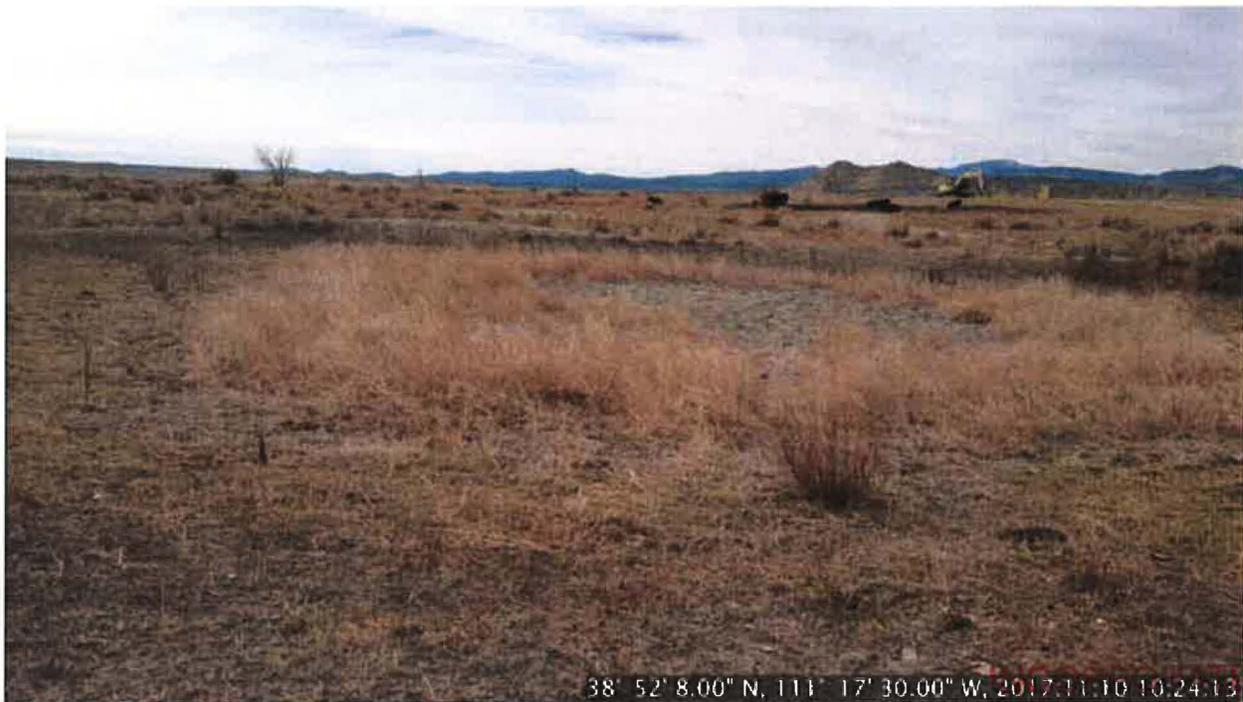
Feature 44. Pond, Livestock Waterer, and Water Line Air Vent. The title and description of this feature have been updated from the Valley Engineering (1980) report. The small pond observed in the area is still intact. However, the two corrals identified in the Valley Engineering report have been removed. The circular pond has a diameter of approximately 100 feet and is currently dry. A stock watering device (MiraFount 3465) installed on a 16 foot square unformed concrete pad is located roughly a 100 yards southwest of the pond. A 15" diameter corrugated

Feature 44. Pond, Livestock Waterer, and Water Line Air Vent. Pond.

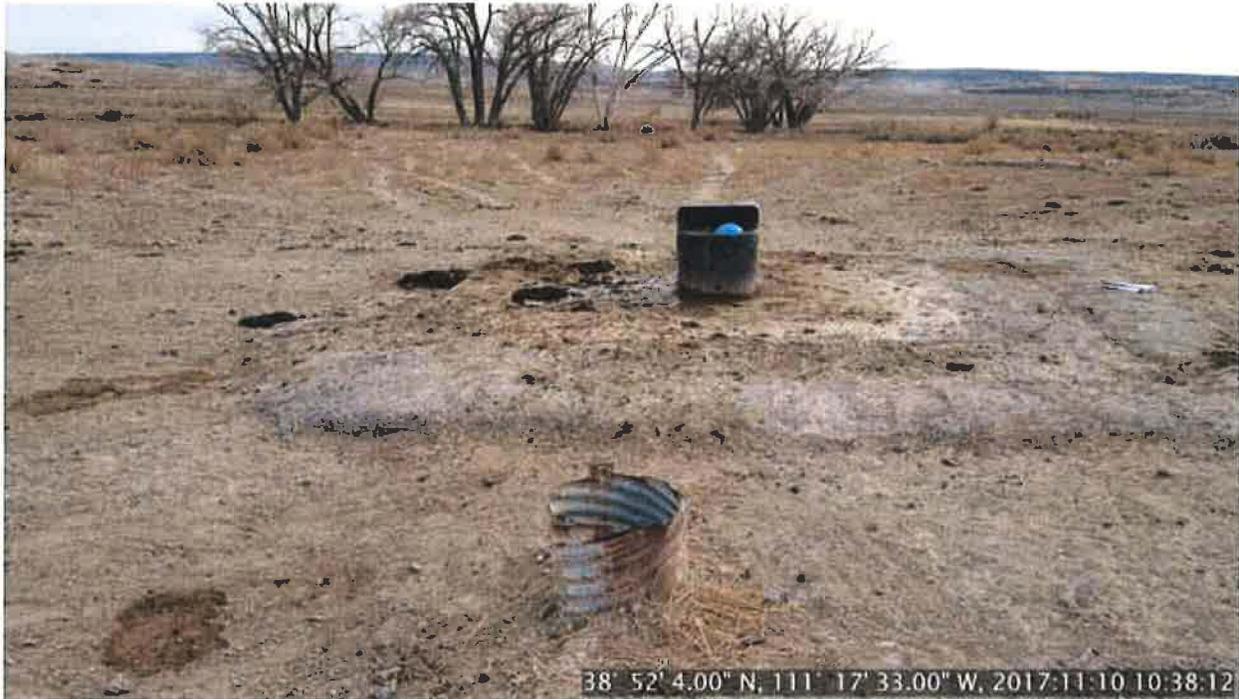
Feature 44. Pond, Livestock Waterer, and Water Line Air Vent. Livestock waterer on concrete slab.

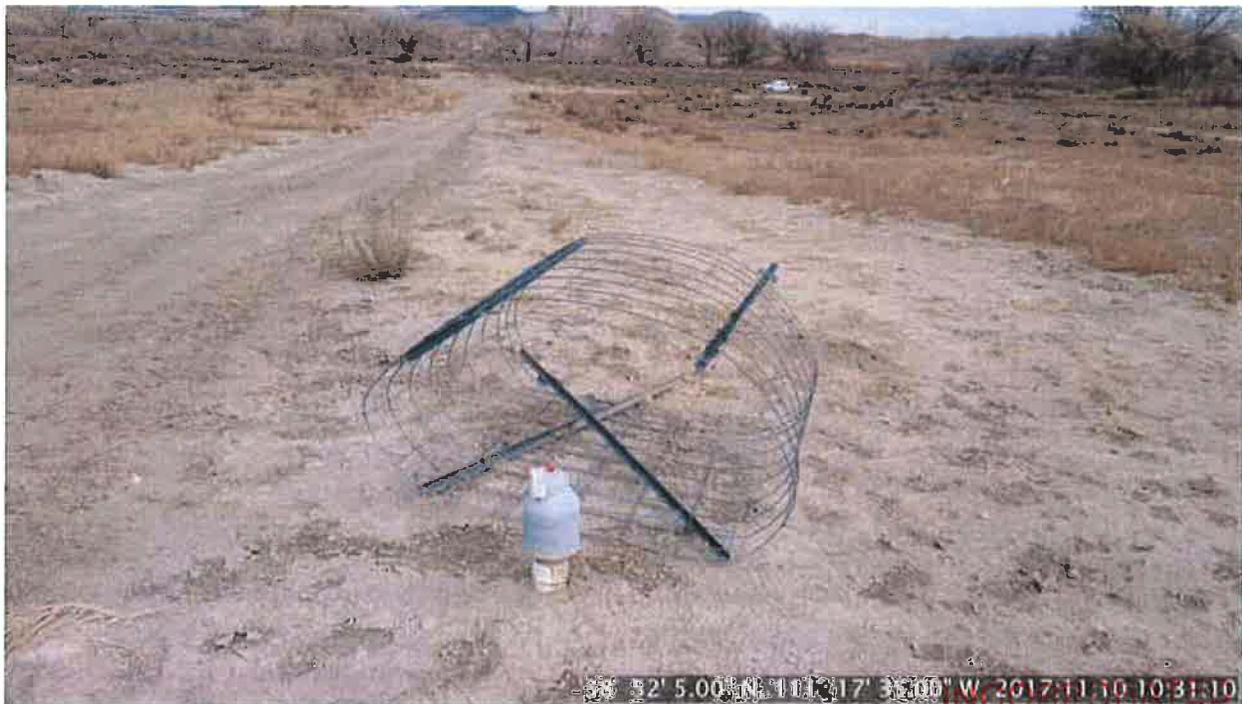
Feature 44. Pond, Livestock Waterer, and Water Line Air Vent. Water line air vent.

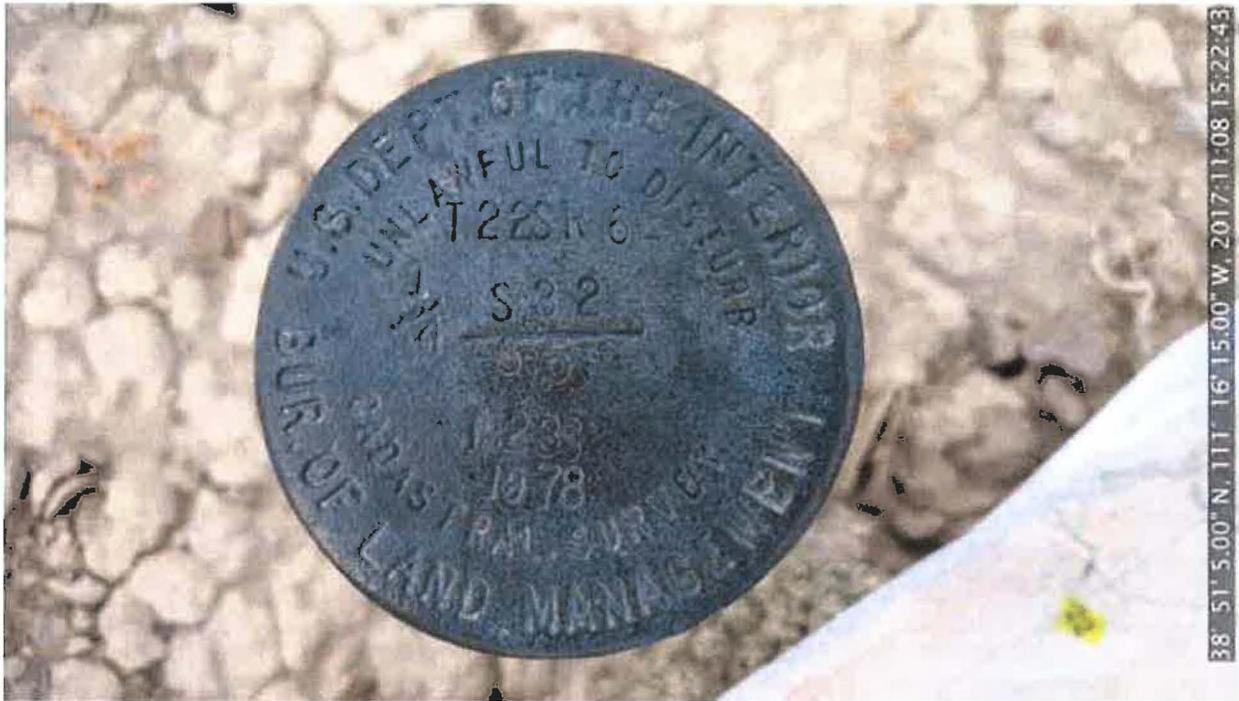
Feature 119. Quarter Section Corner Marker. Top view of maker. Top of photo to north.

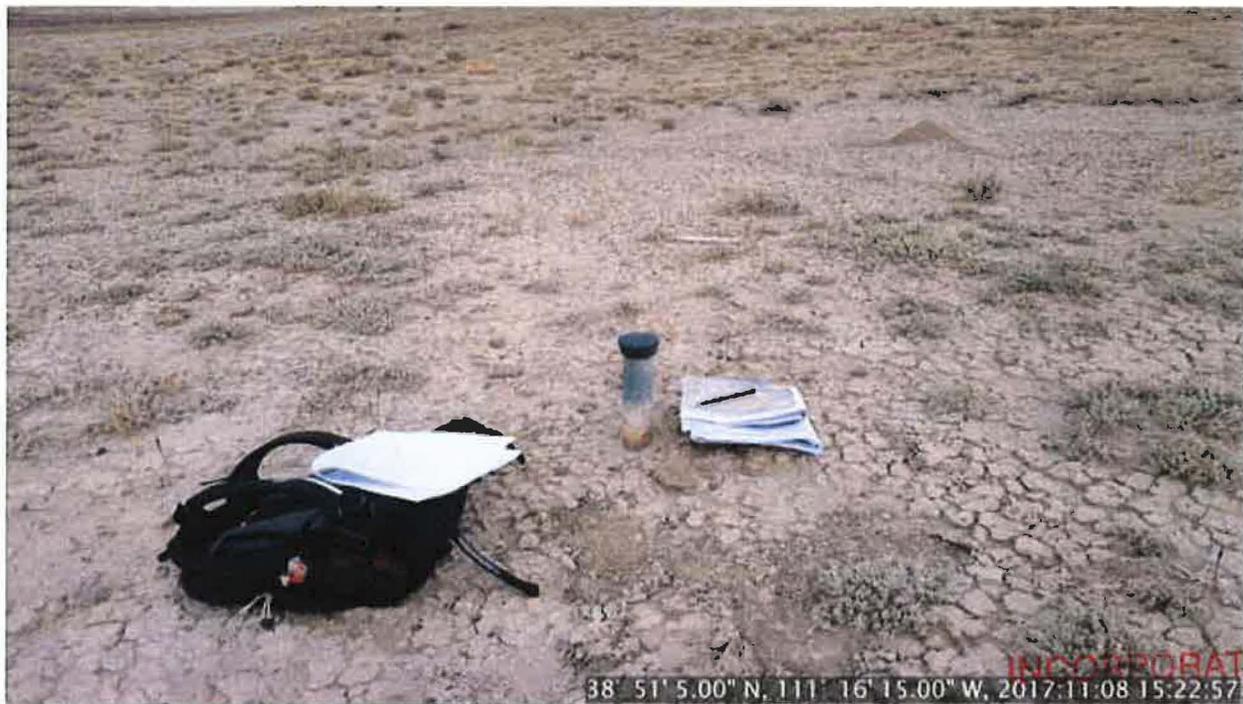
Feature 119. Quarter Section Corner Marker. Looking east.

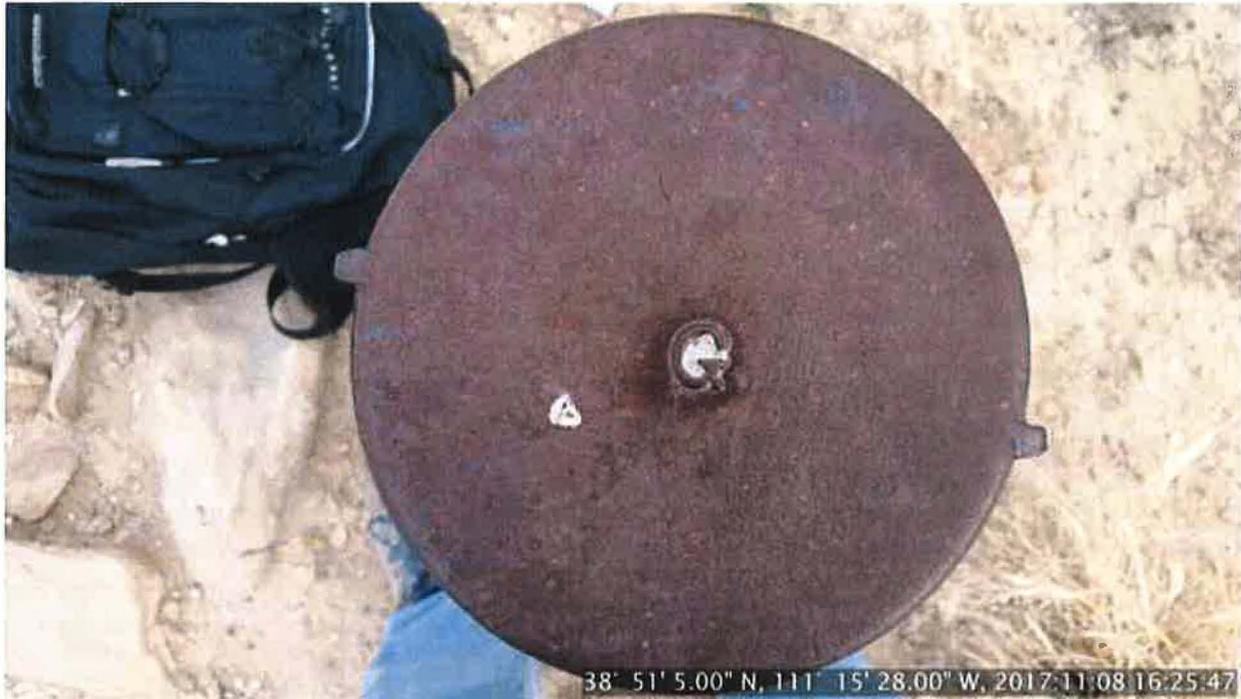
Feature 120. Steel Pipes. This feature description remains essentially the same as described in the Valley Engineering (1980) report, which states the following: “These pipes are approximately 6 inches in diameter with steel caps. The pipes extend about 2½ feet to 3 feet out of the ground. There were three pipes found in this area. The purpose of these pipes is unknown.” Two additions to the above description are added in this document: the steel caps are threaded and only two of the three pipes were found.

Feature 120. Steel Pipes. Top view of 1st pipe.

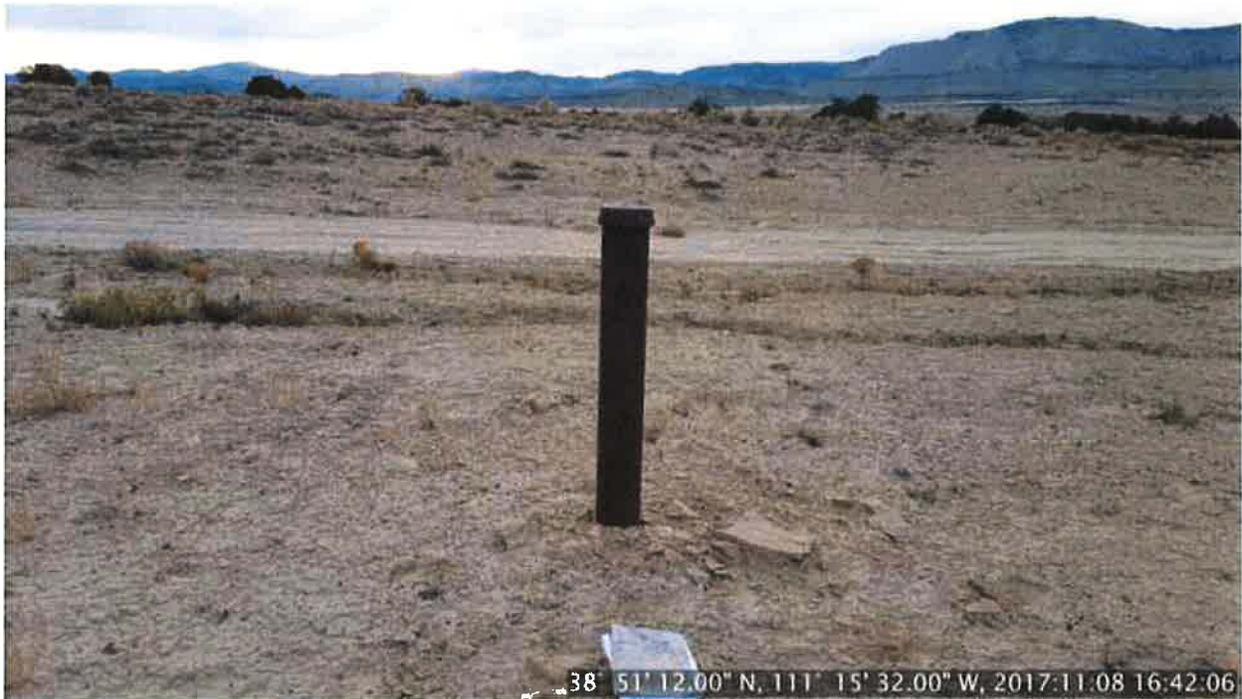
Feature 120. Steel Pipes. Side view of 2nd pipe.

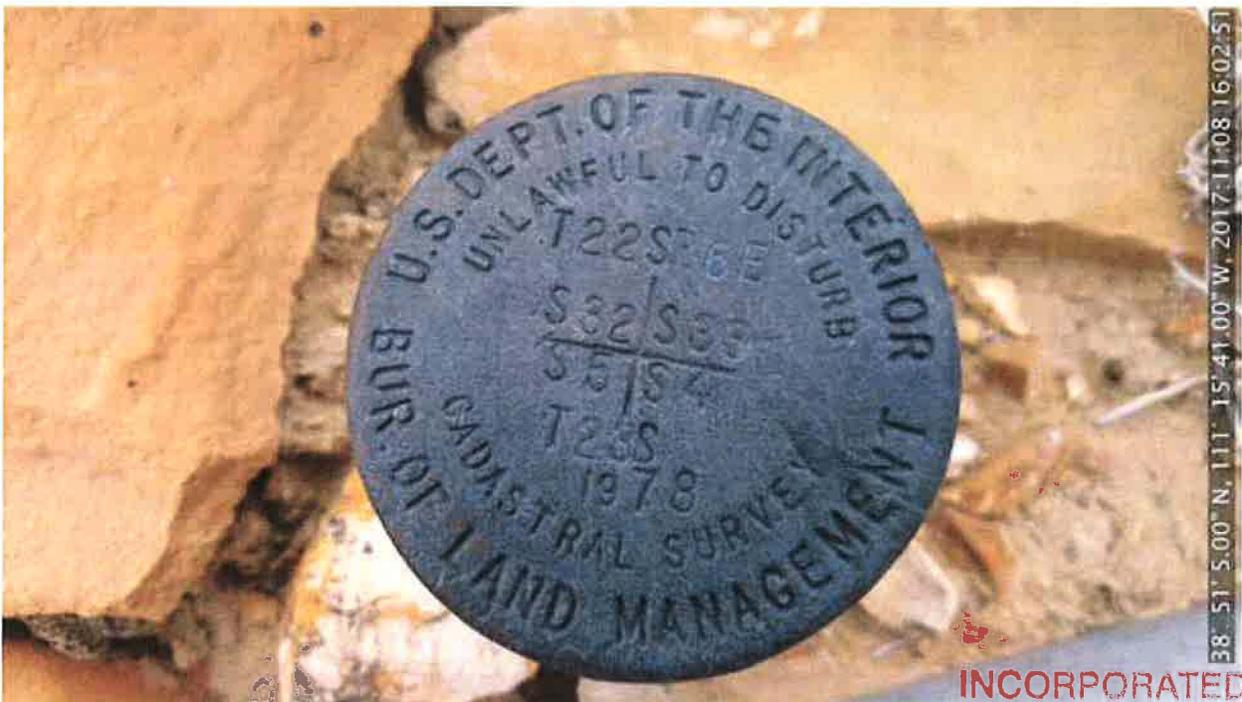
Feature 121. Section Corner Marker. Top view of maker. Top of photo to north.

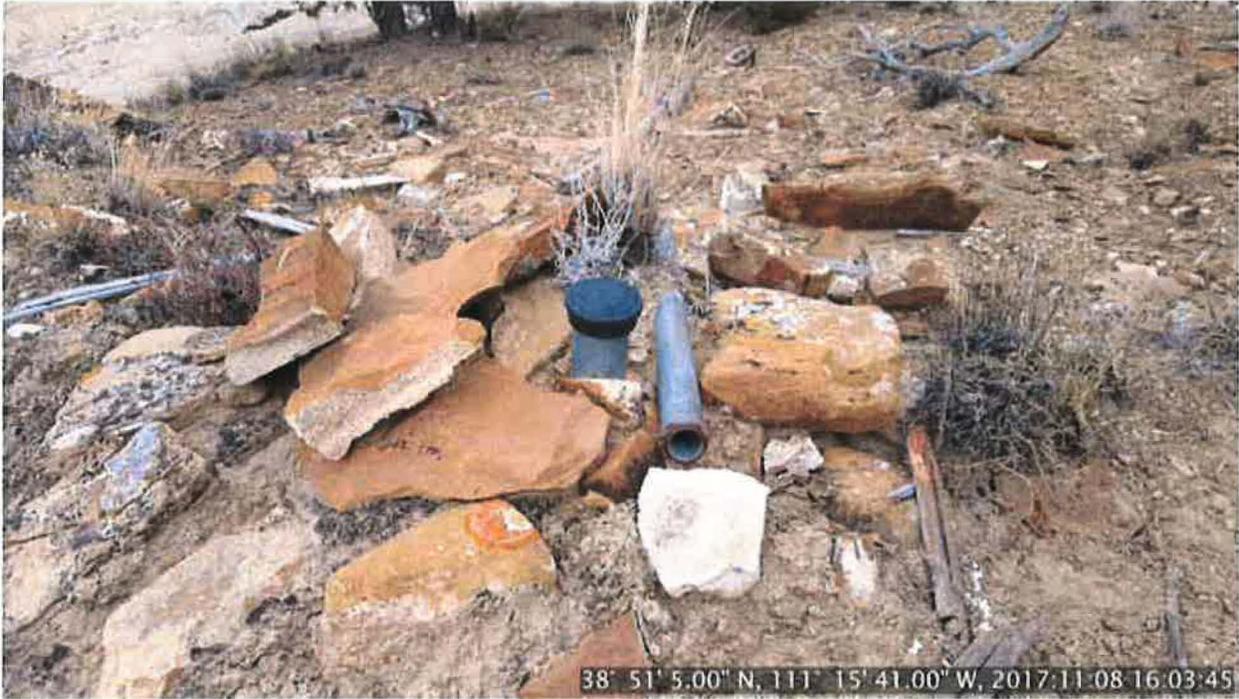
Feature 121. Section Corner Marker. Looking east.
