**RE: Bronco Utah Operations LLC
Emery Mine
DOG M Permit No. C/015/0015
Emery 2 Second Left Panel Full Extraction Revision Clean Copy task 5847**

The purpose of this report is to present baseline surface conditions prior to full extraction operations from the Emery 2 portal of the Bronco Utah Operations, LLC. (Bronco) Emery Mine, Emery County, Utah. The areas covered in this report include the following:

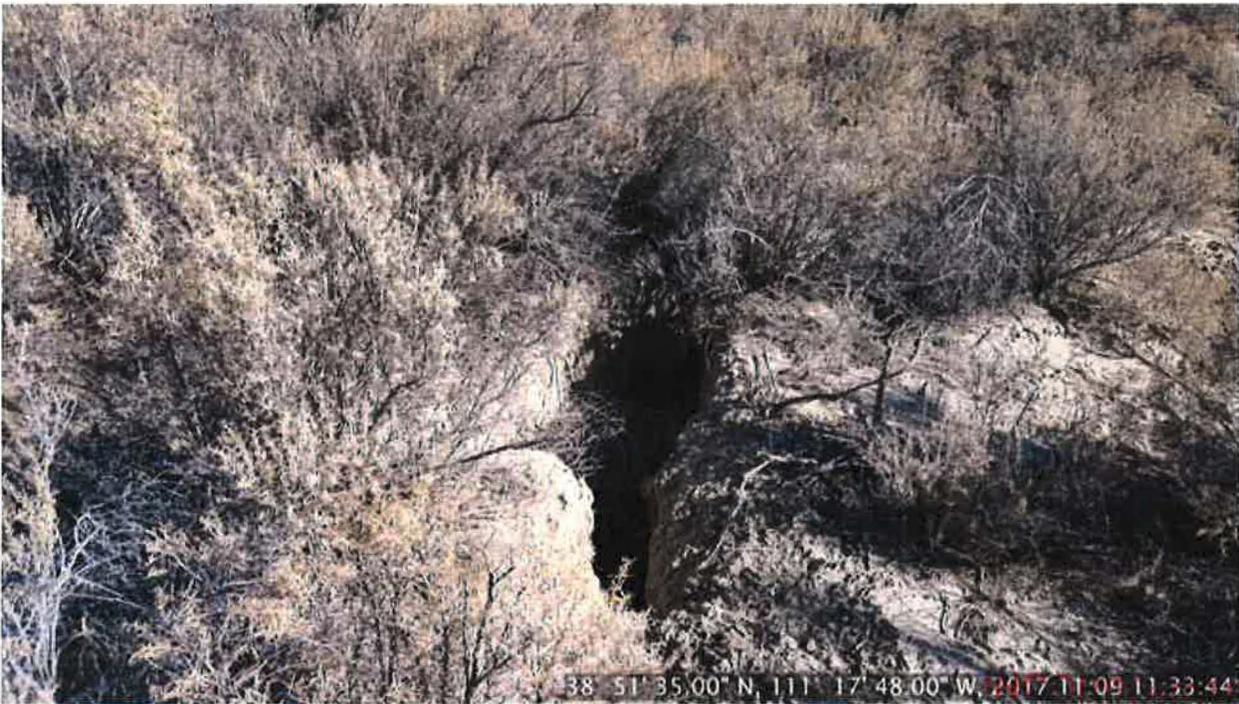
Feature 126. Sinkhole. Looking east.

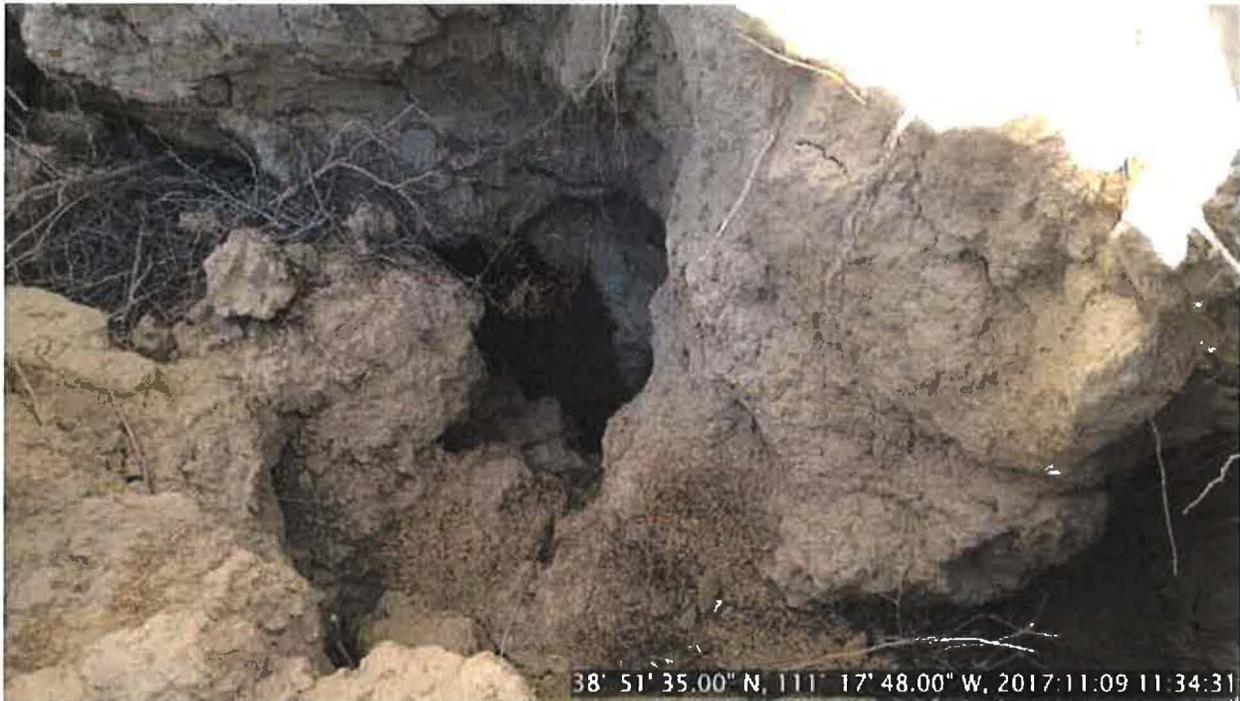
Feature 126. Sinkhole. Top view. Minimum depth is 8 foot.

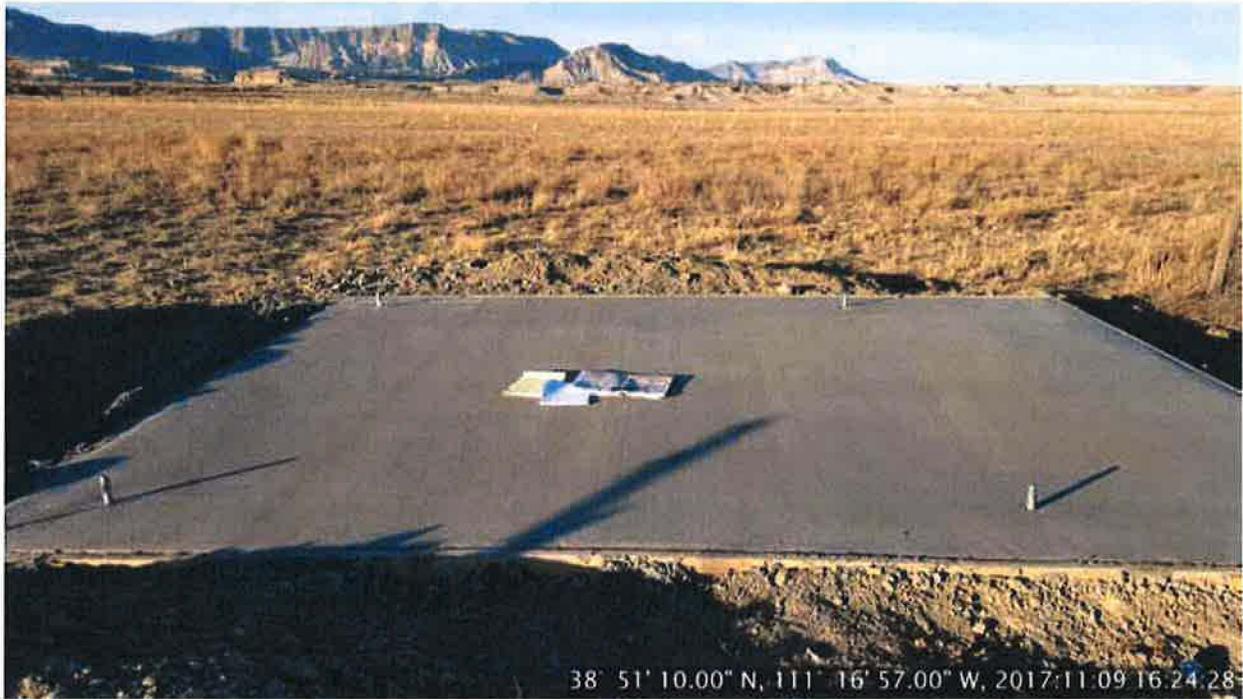
Feature 127. Sprinkler Pivot Foundation. This feature was constructed after the Valley Engineering (1980) report was written. The current landowner is in the process of converting from an open ditch irrigation system to a more efficient pressurized irrigation system consisting of underground buried pipe and irrigation pivots. Newly constructed pivots, pivots under construction, miscellaneous piping and piping supplies, and evidence of recent trenching were encountered in numerous farm land locations within the pre-subsidence survey area.

Feature 127. Sprinkler Pivot Foundation. 2nd location.

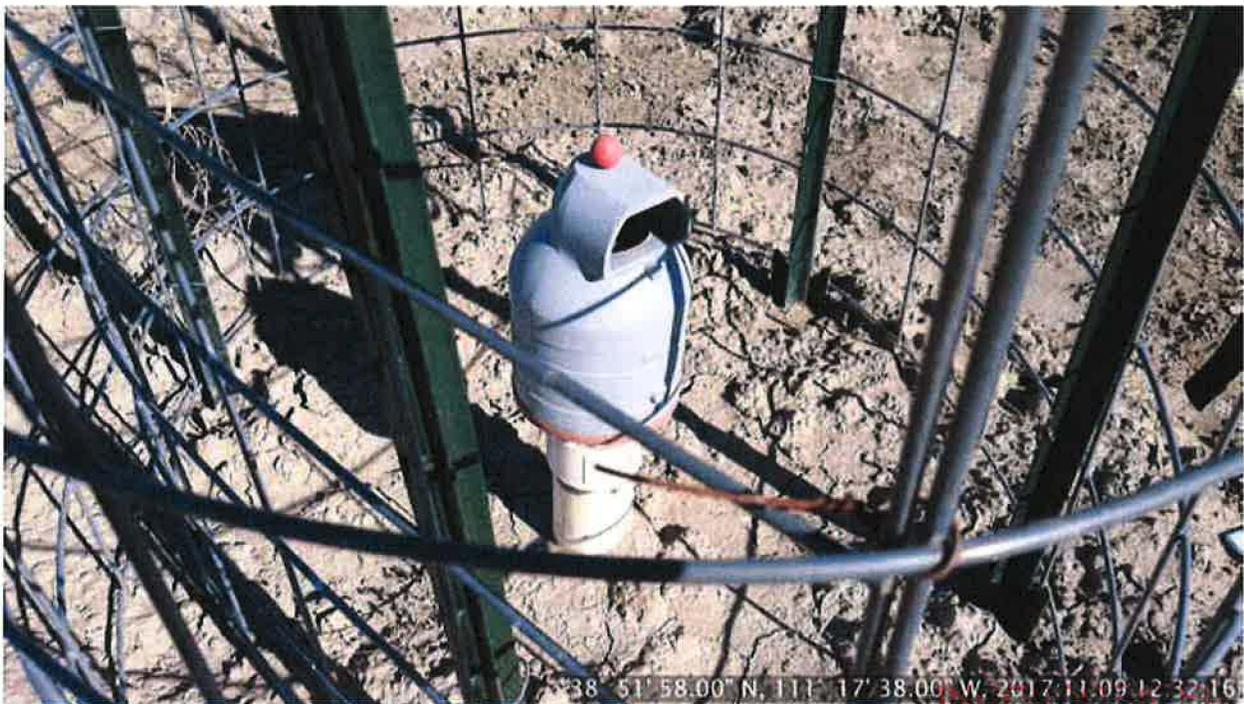
Feature 128. Water Line Air Vent. This feature was constructed after the Valley Engineering (1980) report was written. A water line air vent (Wade Rain PRVC 300) is installed on an underground water line. It is protected from livestock damage by metal tee posts and heavy gauge galvanized wire mesh. The current landowner is in the process of converting from an open ditch irrigation system to a more efficient pressurized irrigation system consisting of underground buried pipe and irrigation pivots. Newly constructed pivots, pivots under construction, miscellaneous piping and piping supplies, and evidence of recent trenching were encountered in numerous locations near this feature.

Feature 128. Water Line Air Vent.

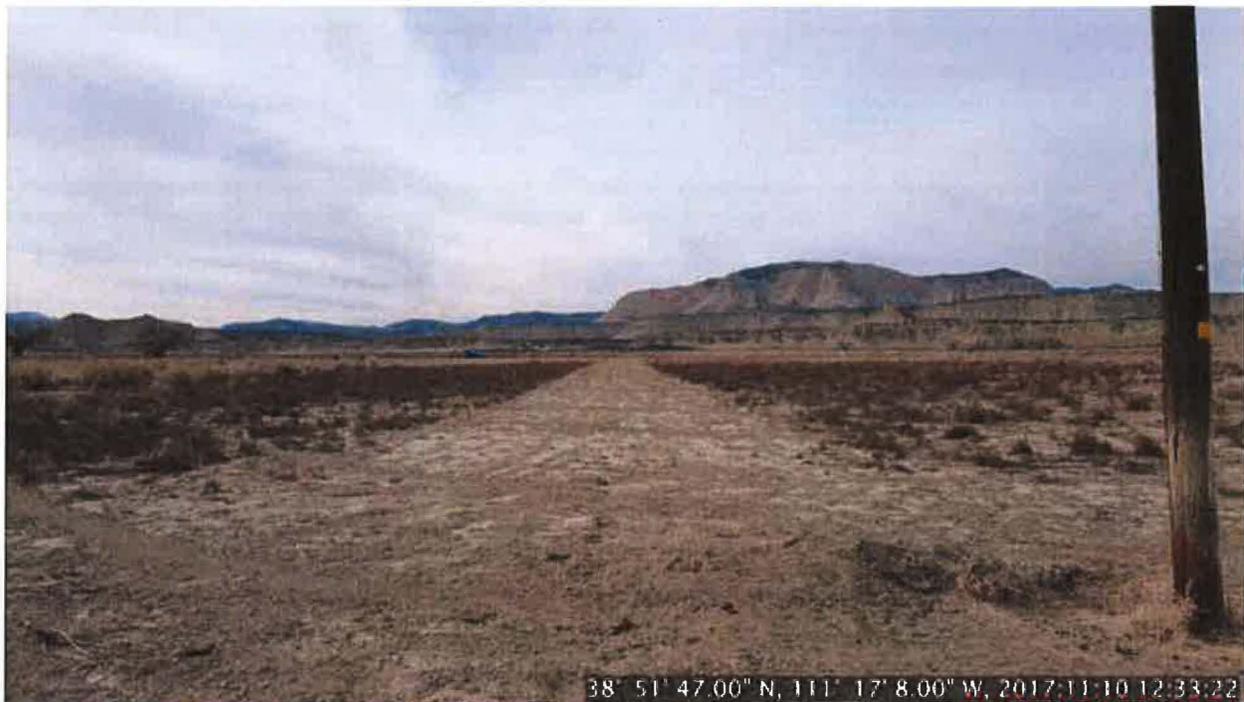
Feature 129. Underground Electrical Feed. Looking west. Disturbed soil where underground electrical line was recently installed to feed a future sprinkler pivot.

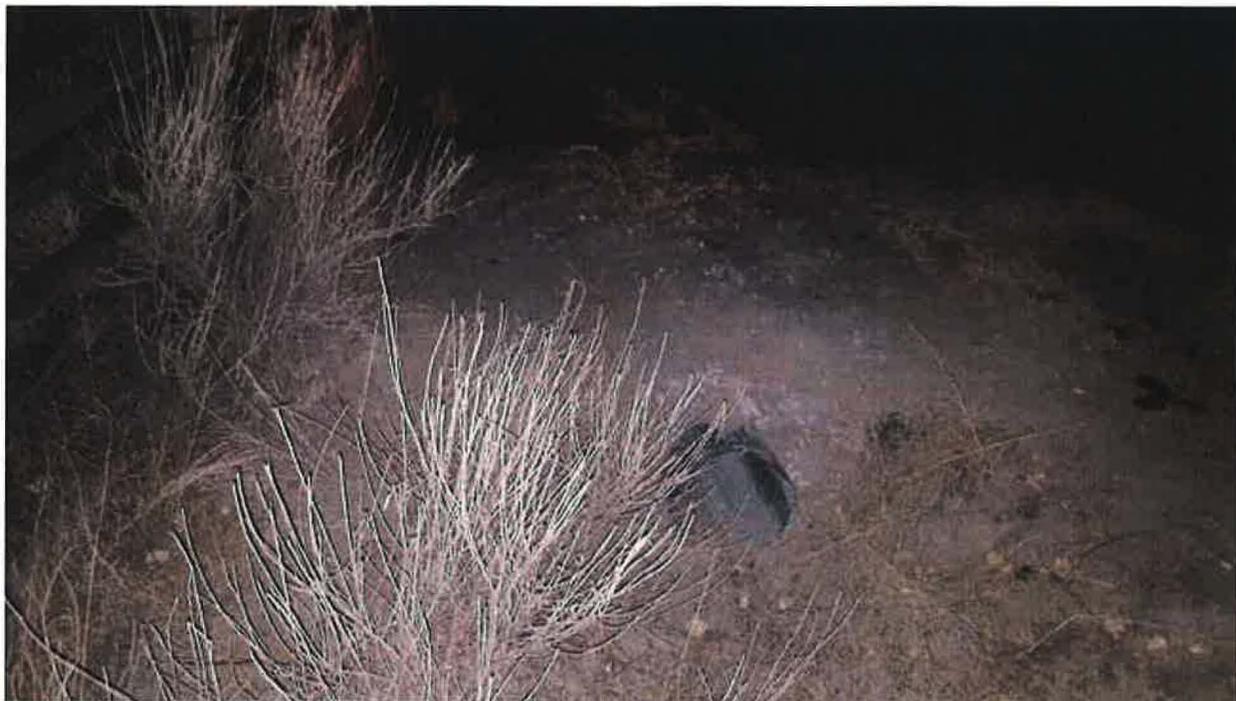
Feature 130. Irrigation Ditch Sinkhole. This feature was discovered by the current land owner, William Boyd Stansfield Jr., after the Valley Engineering (1980) report was written. The closest underground mining activity to this location, 2 West Submains, is located 2,665 feet away. At that distance, it is not possible that historic mining activity caused this feature to form. In addition, future mining activity is very unlikely to affect this feature, because it is located within a buffer zone, depicted on Figure 1 and Plate V-5, where subsidence is not anticipated. Per Mr. Stansfield, a sinkhole opened up across the ditch line in 2015 while the ditch contained flowing irrigation water. The hole measured approximately 5 feet in diameter with an unknown depth. The entire ditch (trapezoidal in shape, measuring roughly 4 feet wide at the top, 1.5 feet wide at the bed, and 2 feet tall) of flowing irrigation water disappeared into this hole and did not surface, he attempted to plug off the hole by installing up to 15 cubic yards of soil into the opening. It became saturated and disappeared into the hole. After turning water out of this ditch, he placed enough soil in the hole to fill it to the surface and installed a 16 inch diameter by 15 feet long length of HDPE piping to cross over the sinkhole. Since that time water has flowed through the 16 inch HDPE pipe, however, he has not exceeded approximately one half of the quantity of water in the ditch that was flowing on the day the sinkhole opened up.

Feature 130. Irrigation Ditch Sinkhole. Looking southeast at HDPE pipe installed over sinkhole.
